Site Inspection Report
Fremont Corp. Mine Site, Emery County, Utah

Date of Inspection: May 23, 1998

The purpose of this site inspection was to document the conditions of the site prior to commencement of mining operations as proposed in a Notice of Intent to Commence Mining ("NOI"), dated February 19, 1998, submitted by H. Michael Keller, on behalf of the lessee.

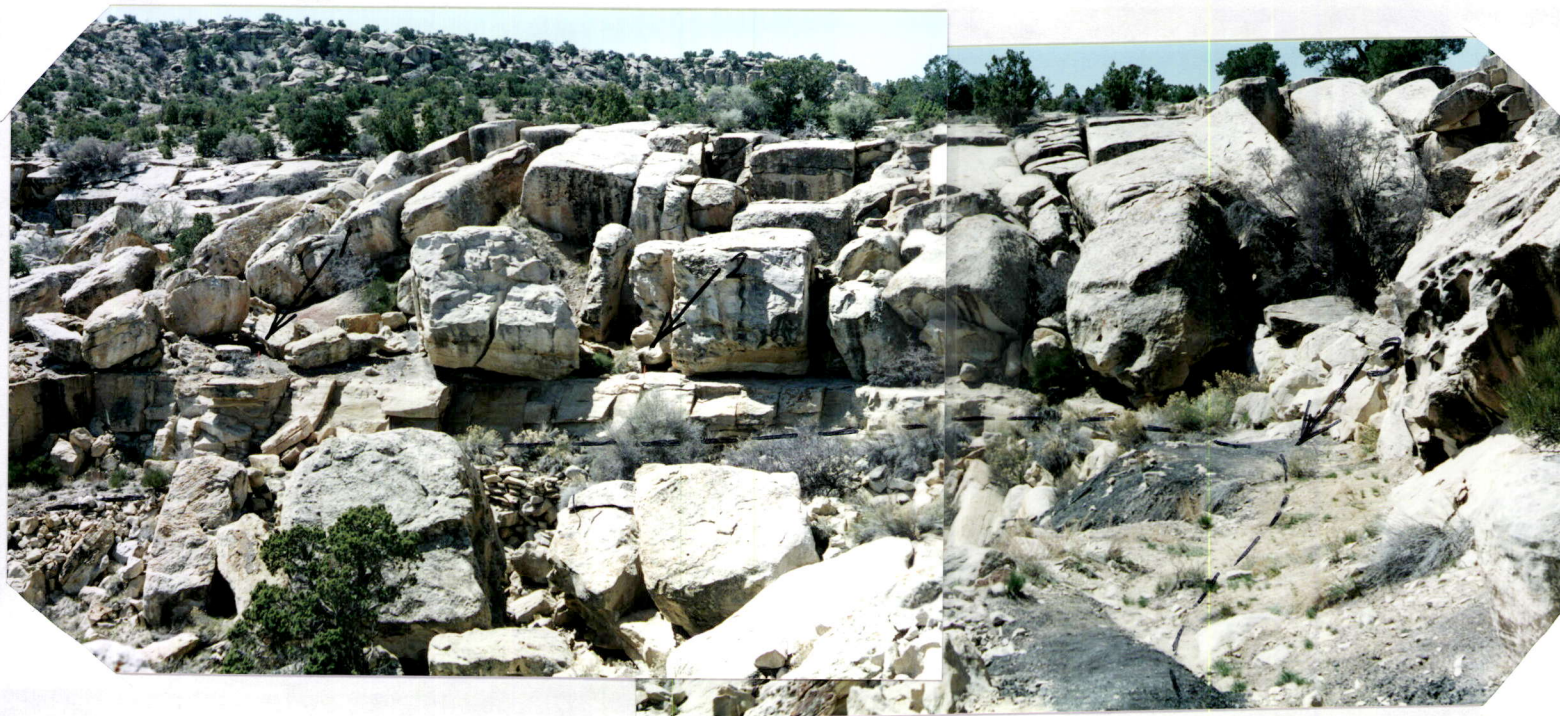
Photo # 1, Looking south along the access road onto the proposed Fremont Corp. mine site. Arrow # 1 shows the location of the survey control point identified on maps submitted by Fremont Corp. as the Rebar control point 6428.71 Elev.. Arrow # 2 is the control point identified as the Nail control point, 6424.17 Elev. Arrow # 3 shows the location of the abandoned and closed Bear Gulch mine site. The dashed line follows the trace of the abandoned road which terminates in the canyon bottom.

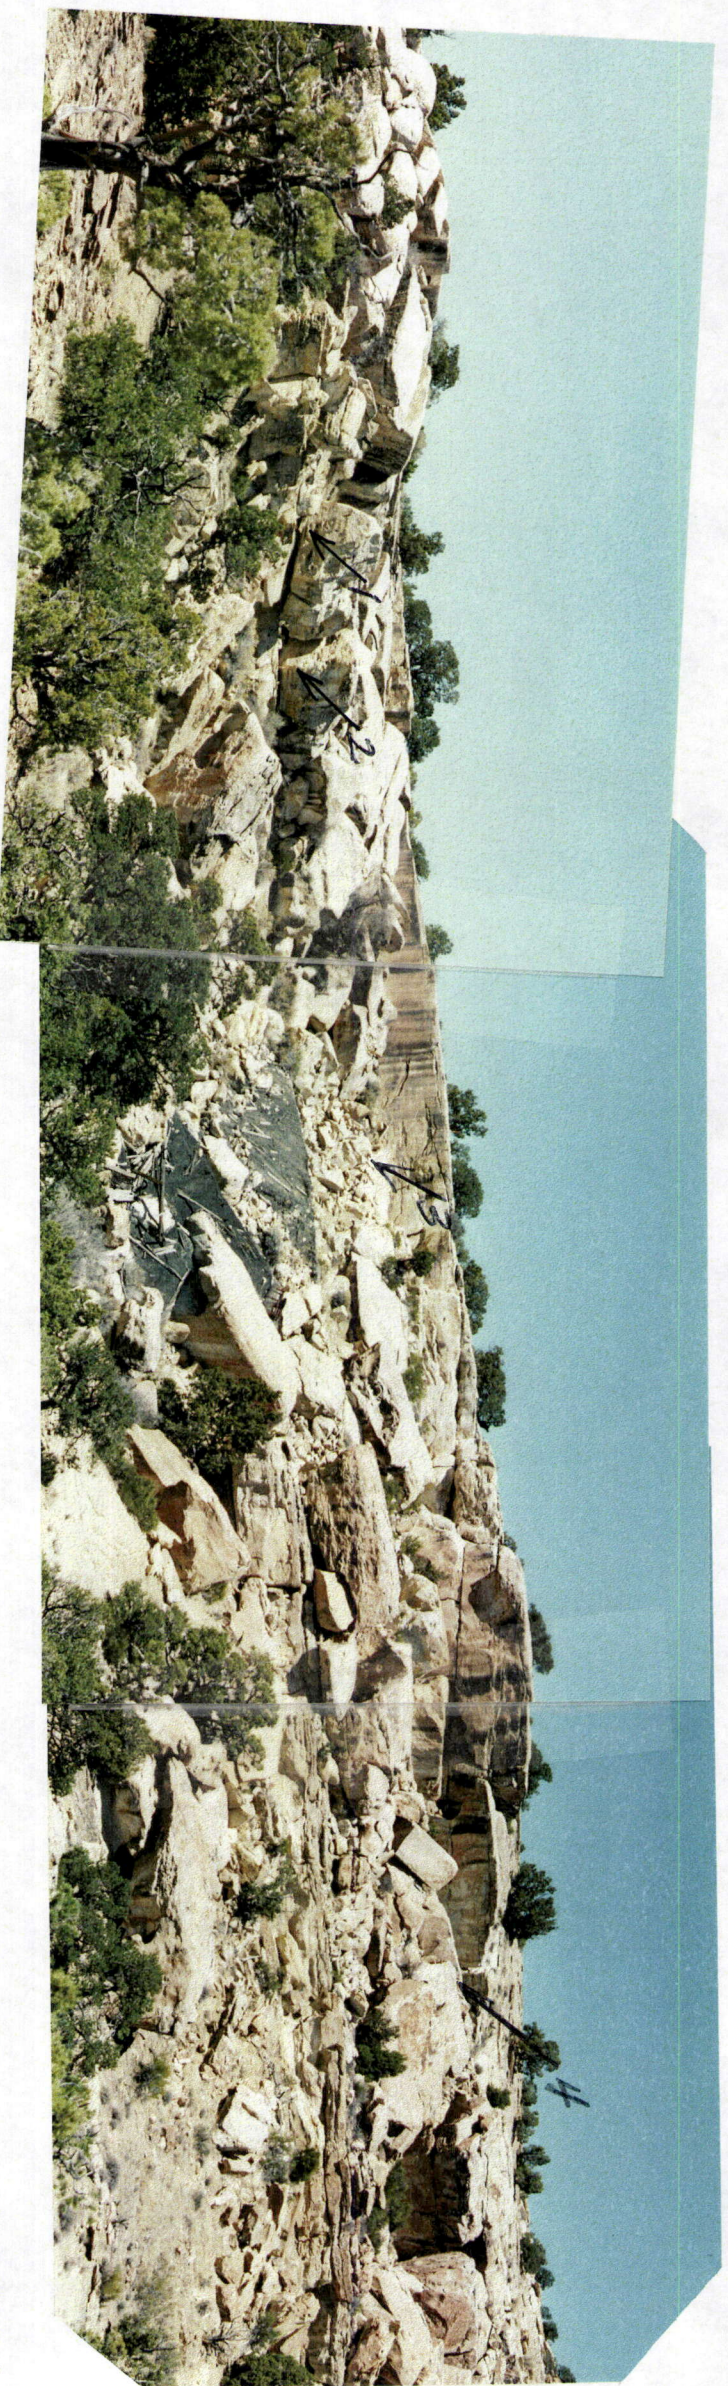
Photo # 2, Looking east from the bottom of canyon below the proposed mine site. Arrows #'s 1 & 2 are respectively the Rebar and Nail control points as shown in photo # 4. Arrow # 3 is the location of the abandoned Bear Gulch mine site and the proposed mine portal site of Fremont Corp. Arrow # 4, on the impassable access road, is the position from where photo # 1 was taken.

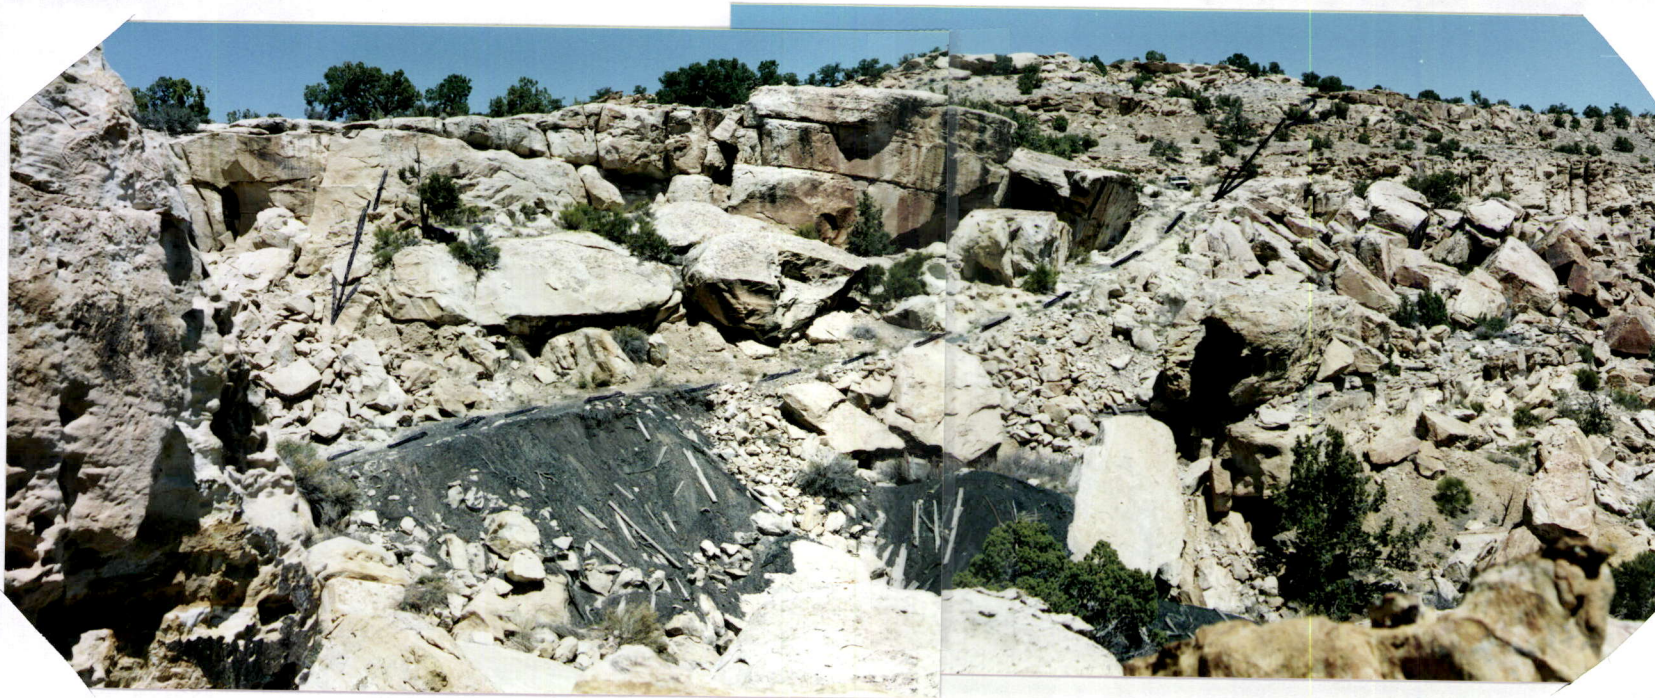
Photo # 3, Looking southwest onto impassable access road to the proposed Fremont mine site, arrow # 1. Arrow # 2 shows the position from where photo # 1 was taken. The dashed line shows the trace of the access road. Note mine debris on the waste dump of the closed Bear Gulch mine.

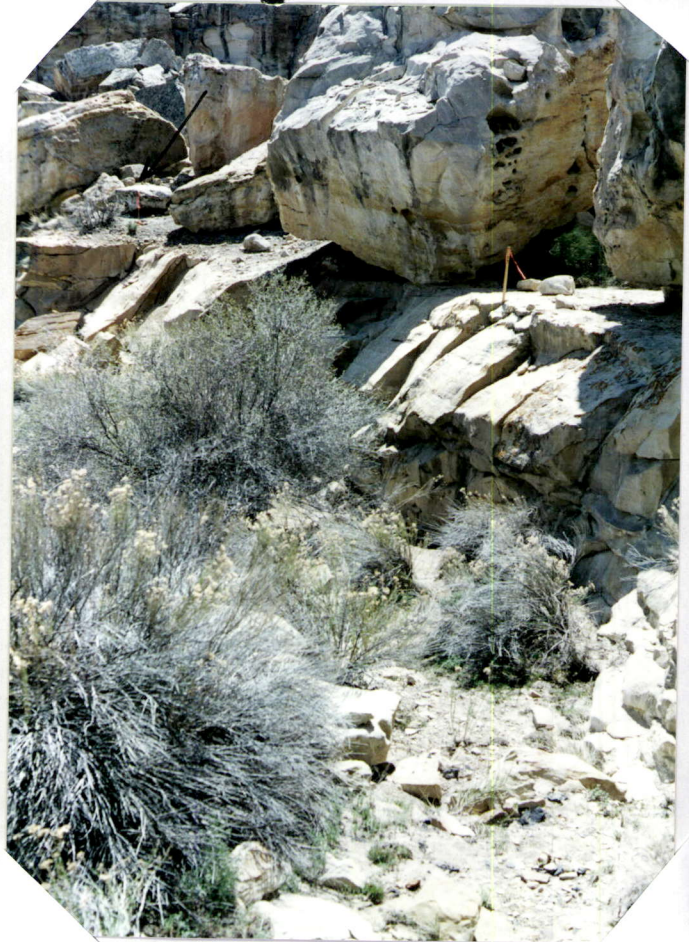
Photo # 4, Looking southeast from the access road onto the Nail survey control point in the foreground and the Rebar survey control point as shown by the arrow

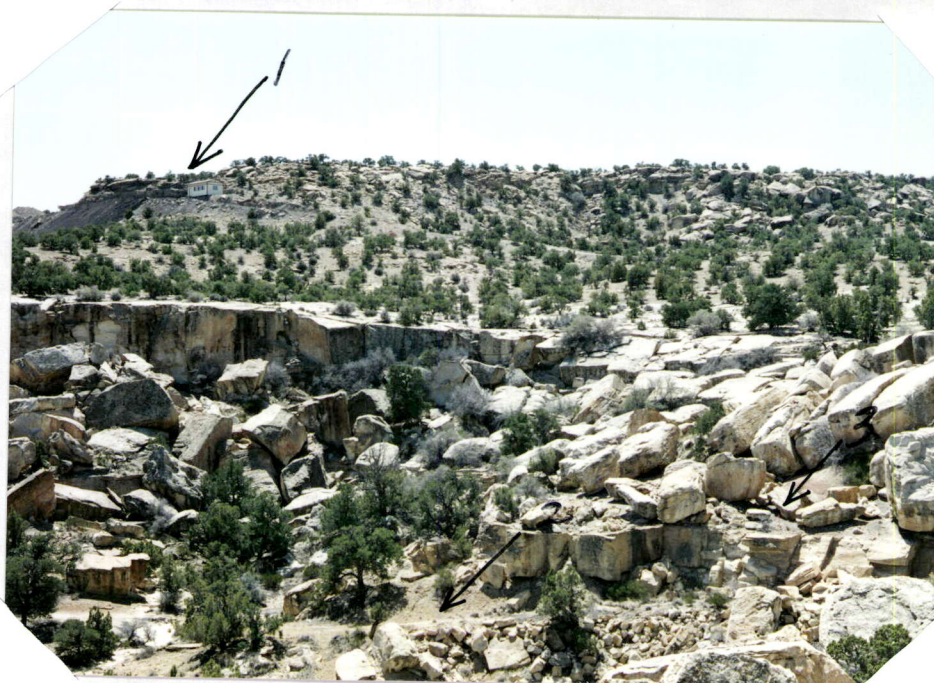
Photo # 5, Looking south-southeast from access road near the north boundary line of section 2. Arrow # 1 shows the location of the Miracle Rock/Rockland mine site. Arrow # 2 shown the location of the access road that terminates at the bottom of the canyon and arrow # 3 shows the location of the Rebar survey control point.
